Transport Access Program 3 | Footbridge St Marys MCC

Heavy Vehicle Local Roads Report

Document details	
Title	Heavy Vehicle Local Roads Report
Client	Transport for New South Wales
Planned commencement date	November 2023
Estimated completion date	November 2027

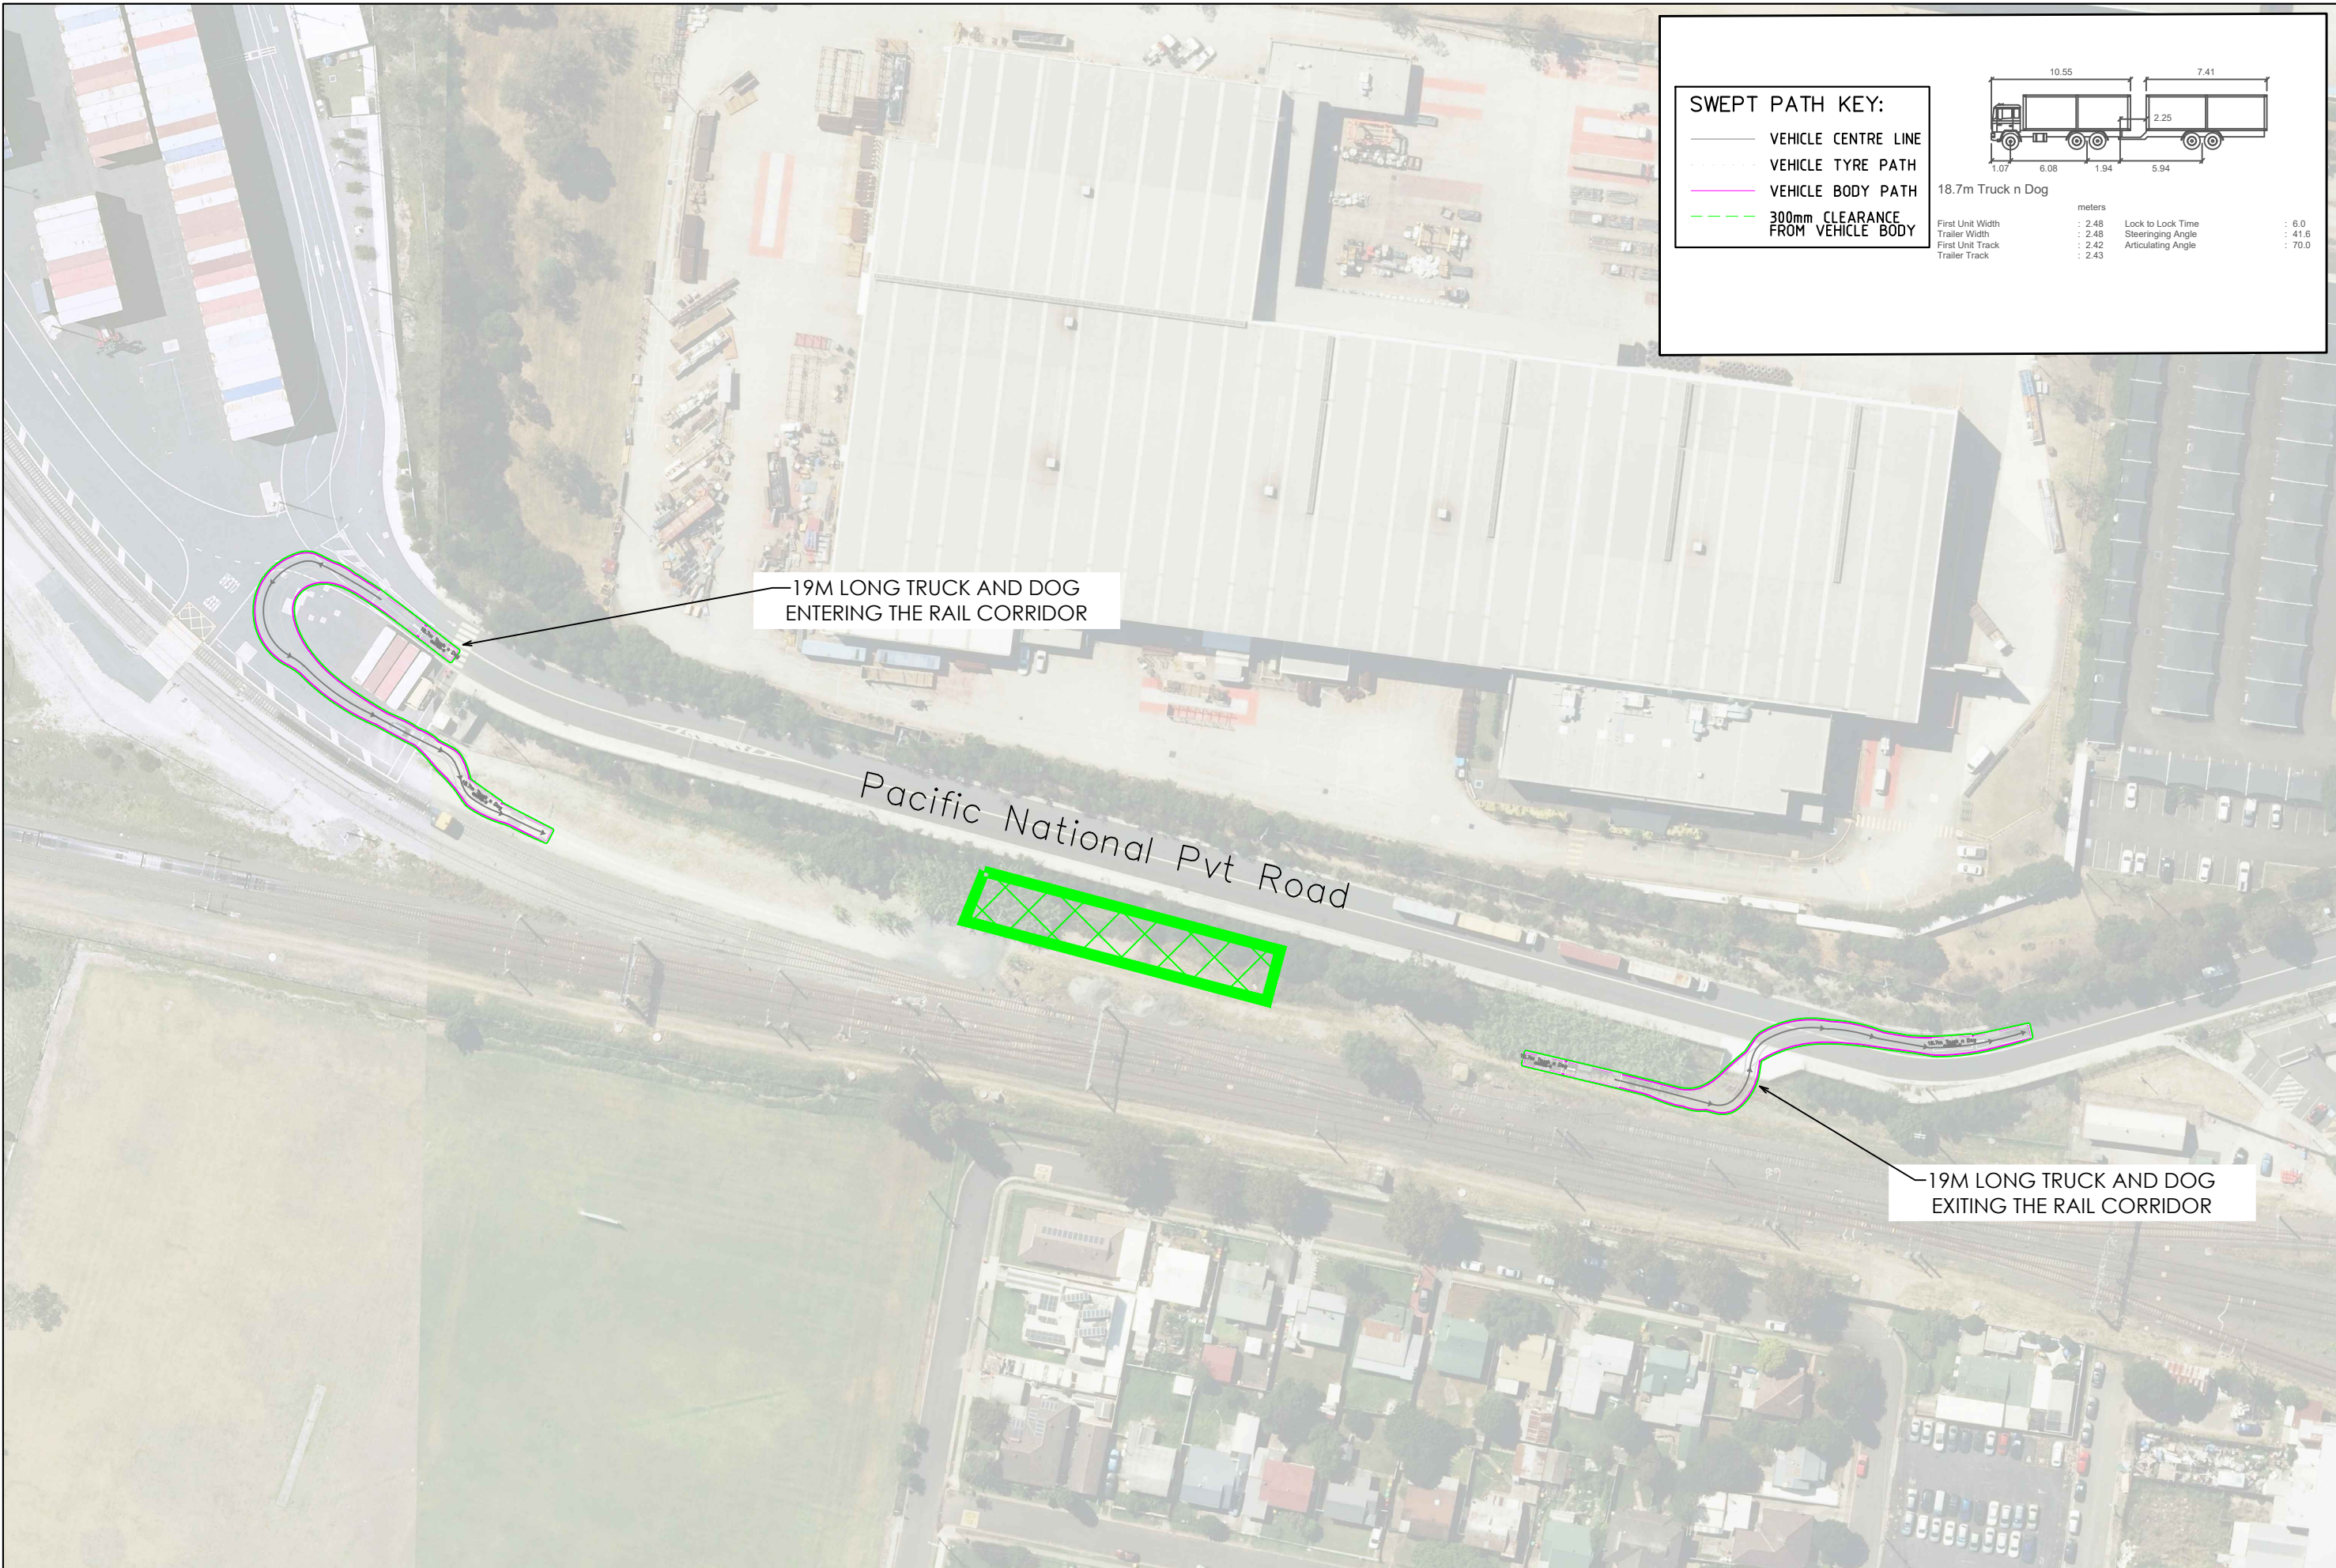
SWEPT PATH KEY:

- VEHICLE CENTRE LINE
- VEHICLE TYRE PATH
- VEHICLE BODY PATH
- 300mm CLEARANCE FROM VEHICLE BODY

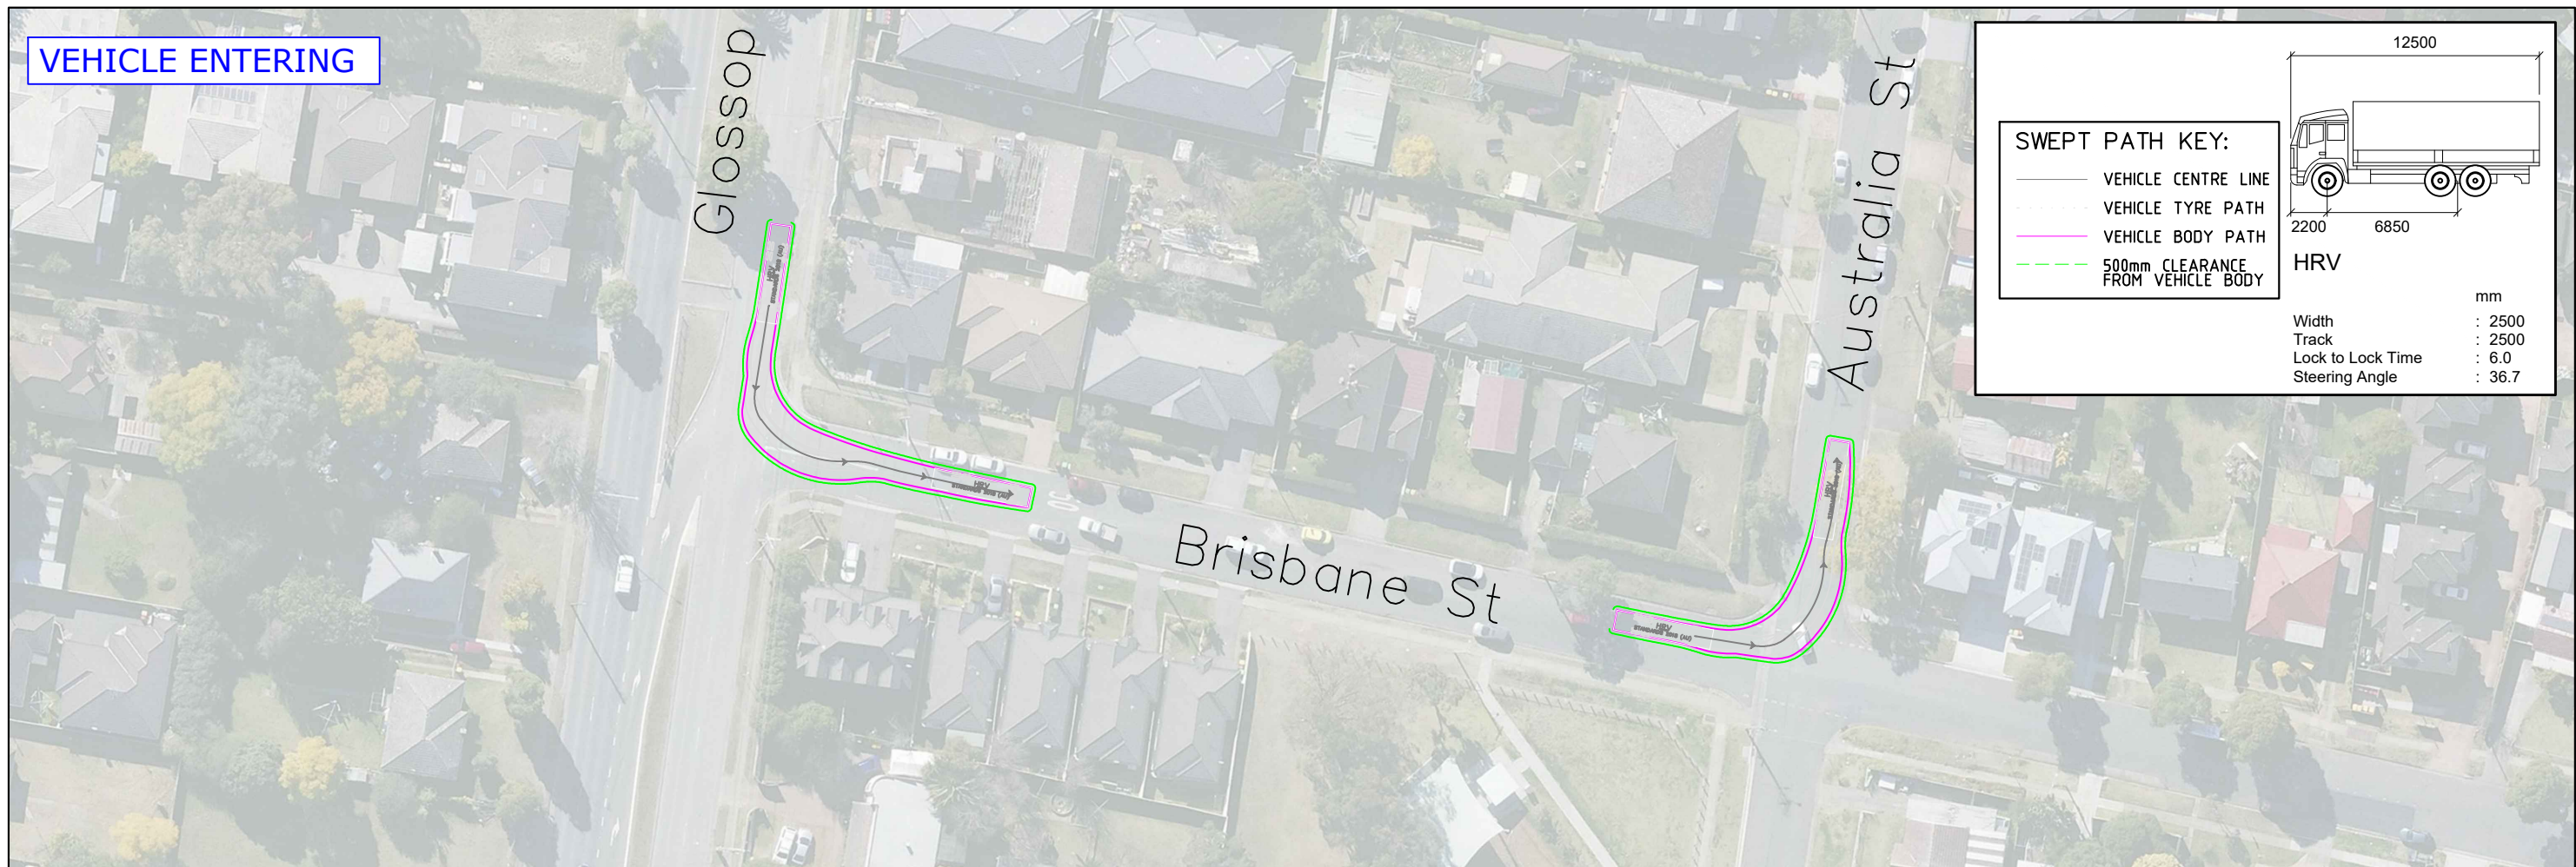
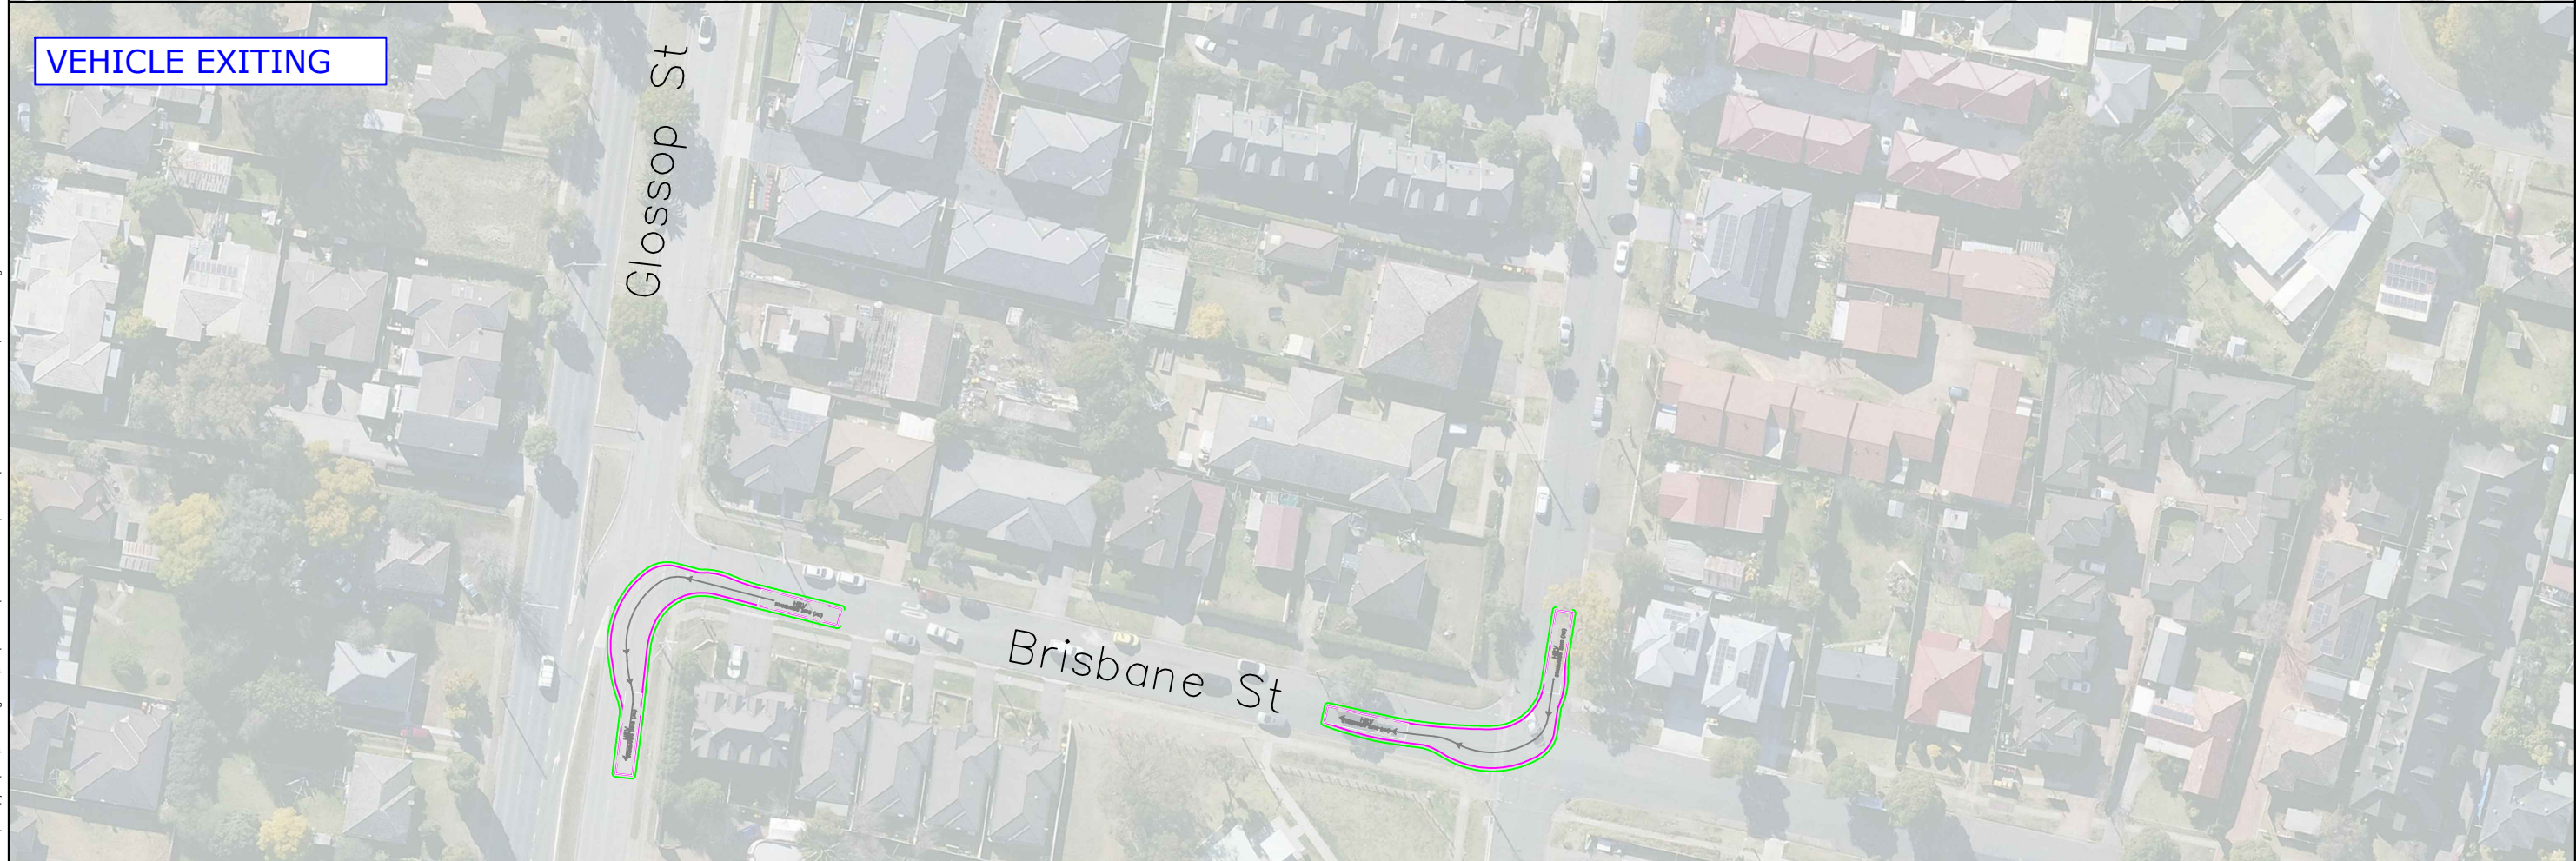
VEHICLE ENTERING

- VEHICLE CENTRE LINE
- - - VEHICLE TYRE PATH
- VEHICLE BODY PATH
- - - 500mm CLEARANCE FROM VEHICLE BODY

Width : 2500
Track : 2500
Lock to Lock Time : 6.0
Steering Angle : 36.7

VEHICLE EXITING

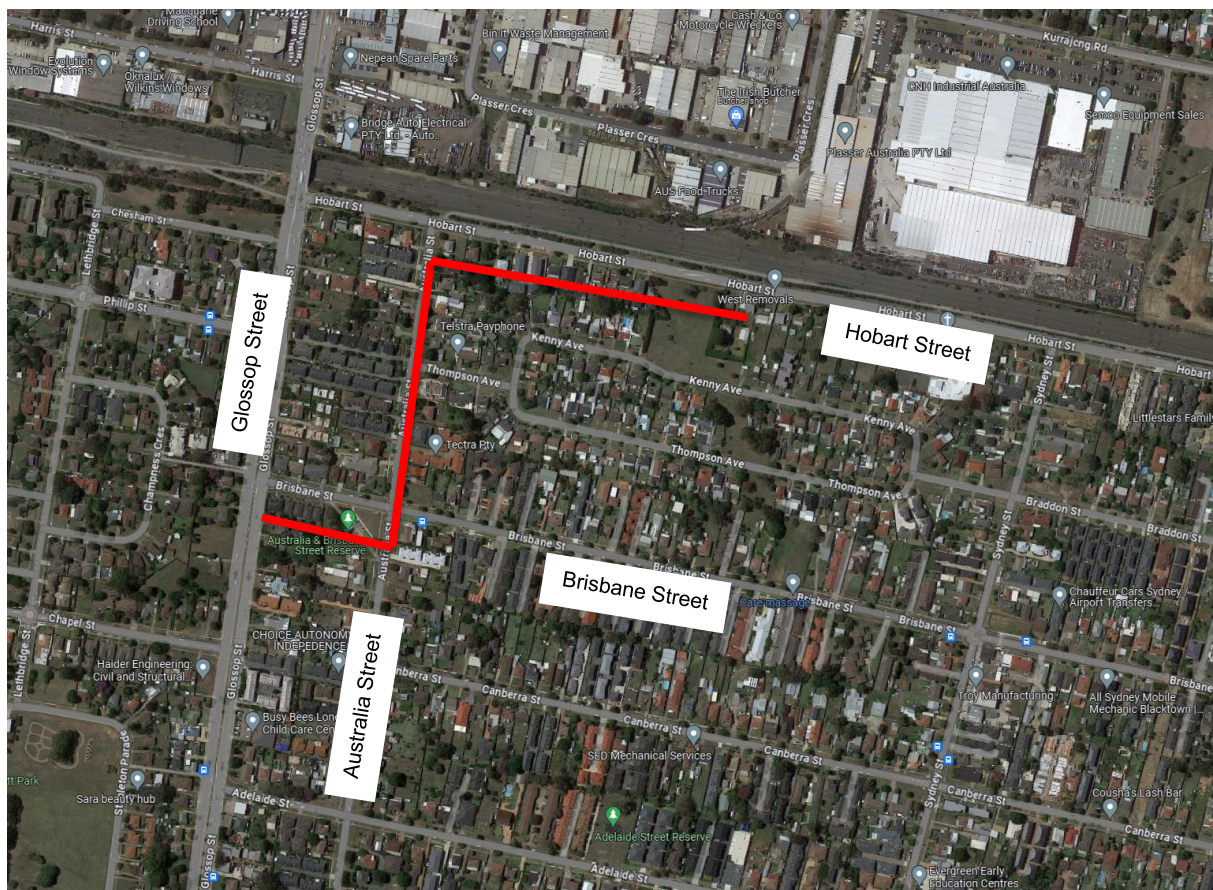
Figure 1: Road Safety Audit Scope

The site being audited covers the areas affected by changes, including the removal of the traffic blisters and islands and the installation of road plates on Grand Avenue. The areas that are the subject of this audit is the red area shown in Figure 1, below;

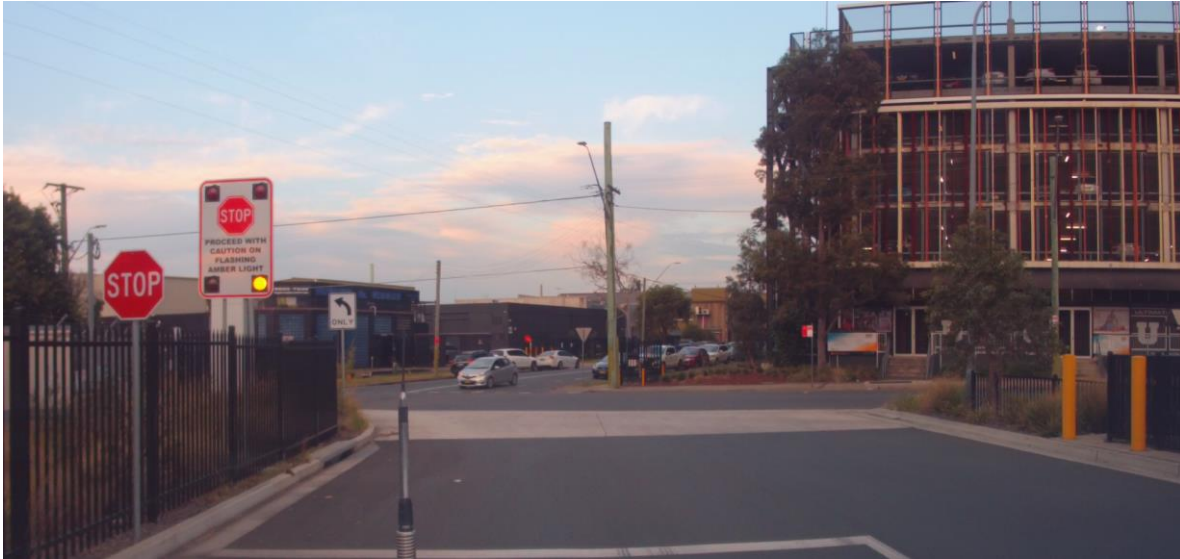
No.	Location / Document reference	Description of Deficiency / Observation	Risk level
1	Private access road, turning onto Forresters Road	The stop bar and STOP sign is positioned a long way from through traffic. It is not possible to clearly see oncoming traffic, to allow giving way. It is noted however that there is ample room to roll forward to allow visibility.	Note only

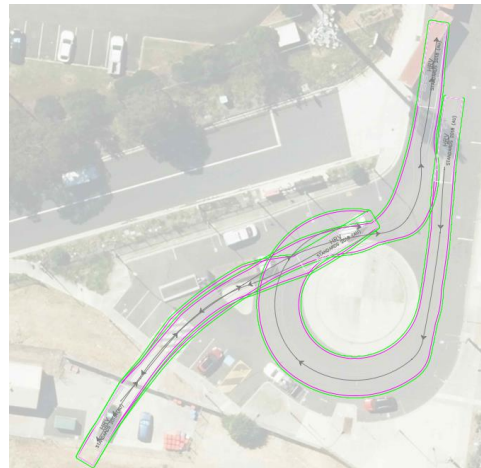
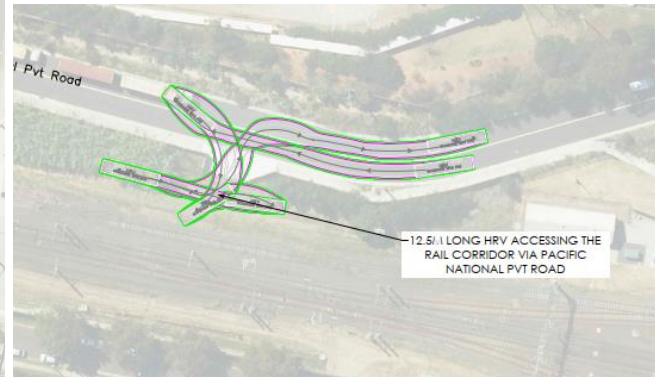
There appears to be ample room to turn heavy vehicles around at the roundabout and areas proposed for use under the HVLR. There are however some instances where vehicles are proposed to be reversing over pedestrian footpaths. It is unclear how this operation will be undertaken, and if there is any pedestrian demand on the footpaths.

Should the footpaths be regularly trafficked by pedestrians, it may result in an increased probability of vehicles and pedestrian collisions.

Likelihood – Rare

Severity – Serious

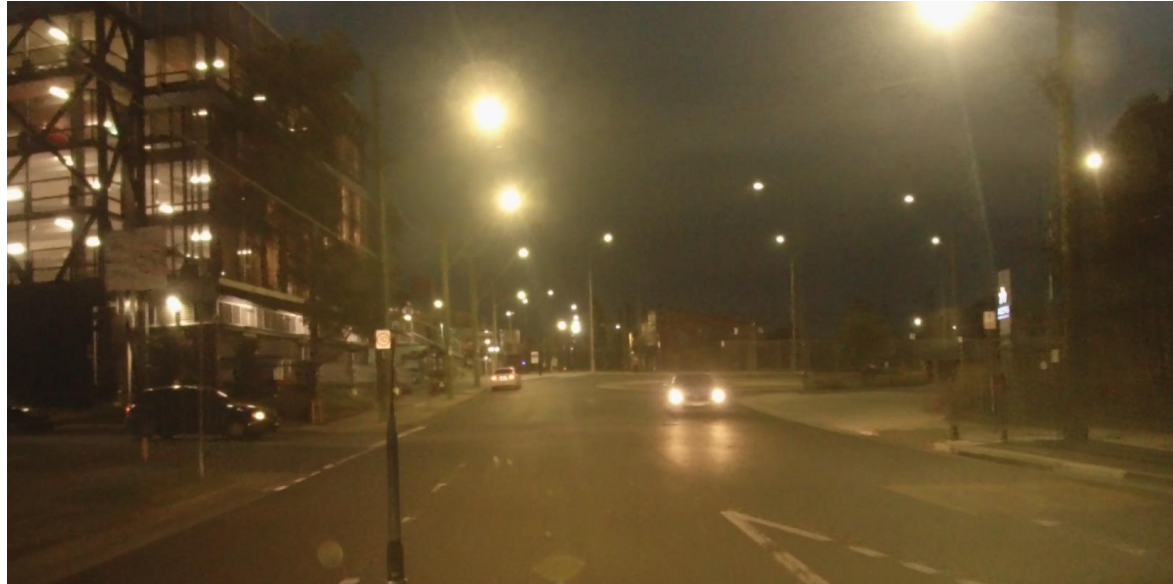
The linemarking approaching the southern end of Forresters Road is deteriorated in places reducing the ability to determine lane configurations. This may result in some drivers deviating from their lane, and resulting in poor lane positioning or an increased risk of side-swipe type collisions.

It is noted that approaching the roundabout section the operating speed of traffic is very low, resulting in a very low probability of an incident.

Likelihood – Unlikely

Severity – Minor
